ROOFING REPORT

12 Oak St, Nashville, TN 37206

October 1, 2026

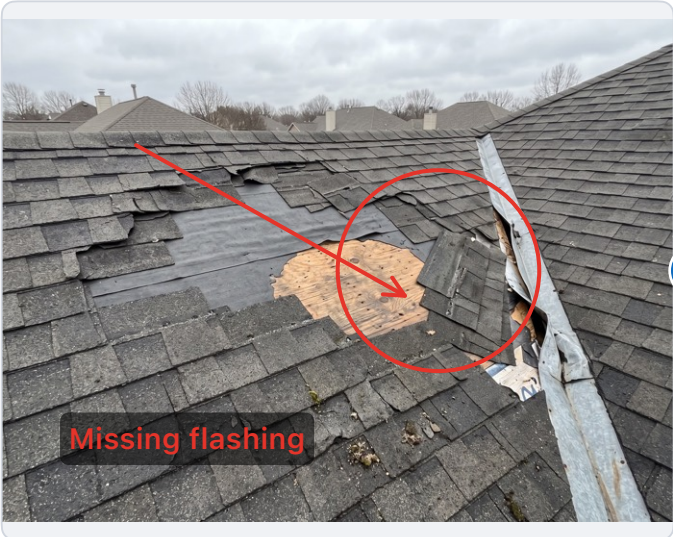
BEFORE

Missing shingles, decking exposed

Replaced 14 sheets of decking and installed new synthetic underlayment.

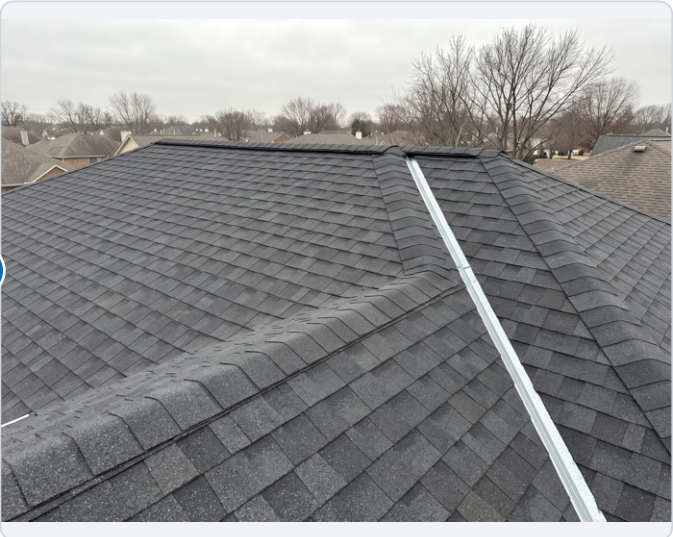
AFTER

New shingles and flashing installed

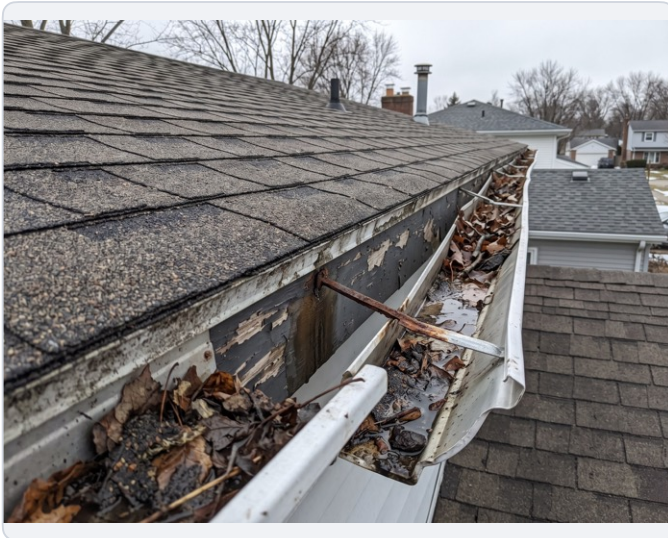
**BEFORE**

Gutter pulled loose, packed with debris

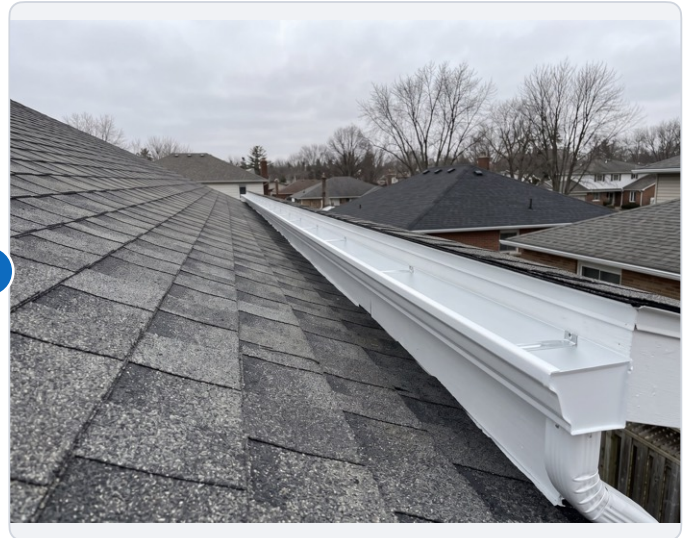
**AFTER**

New seamless gutter, fascia repainted

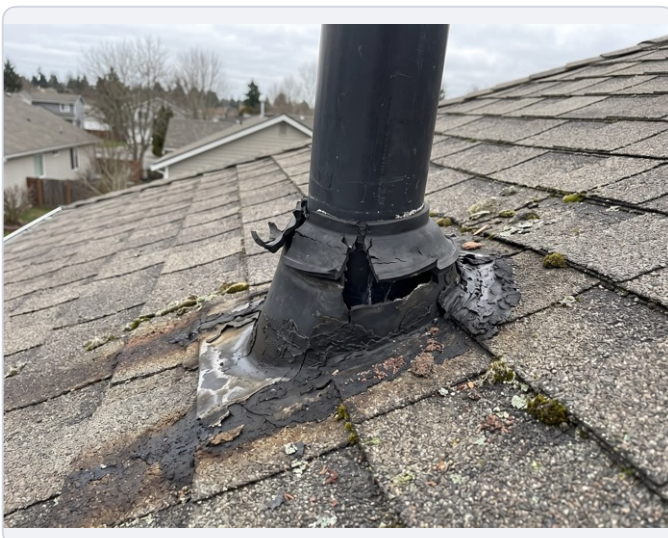
**BEFORE**

Vent boot split and leaking

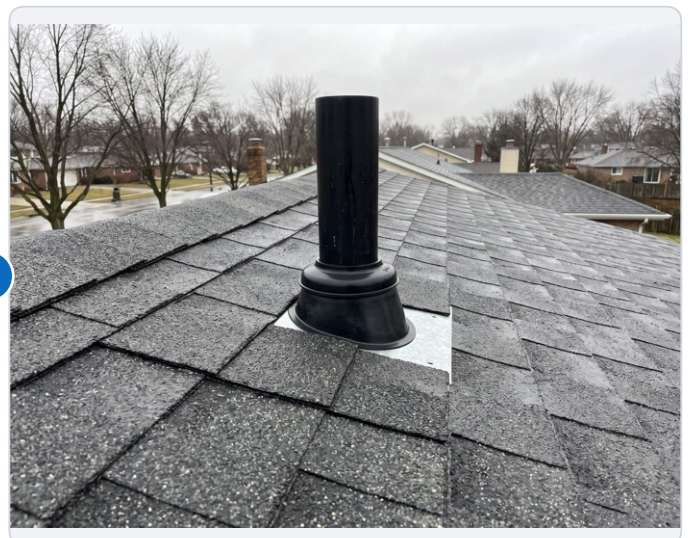
**AFTER**

New pipe boot, sealed and flashed
